Subject: Phase I Report for Property located in San Francisco, CA

Christopher M. French, R.G. is pleased to present this Phase I report for property located in the vicinity of the Yosemite-Fitch Outfall Consolidation project in the City and County of San Francisco, California. The scope of work included a compilation and evaluation of findings to date pertaining to 1) physical setting, 2) contaminant source verification, 3) hazardous waste characterization, and 4) risk assessment.

#### 1.0 BACKGROUND AND EXECUTIVE SUMMARY

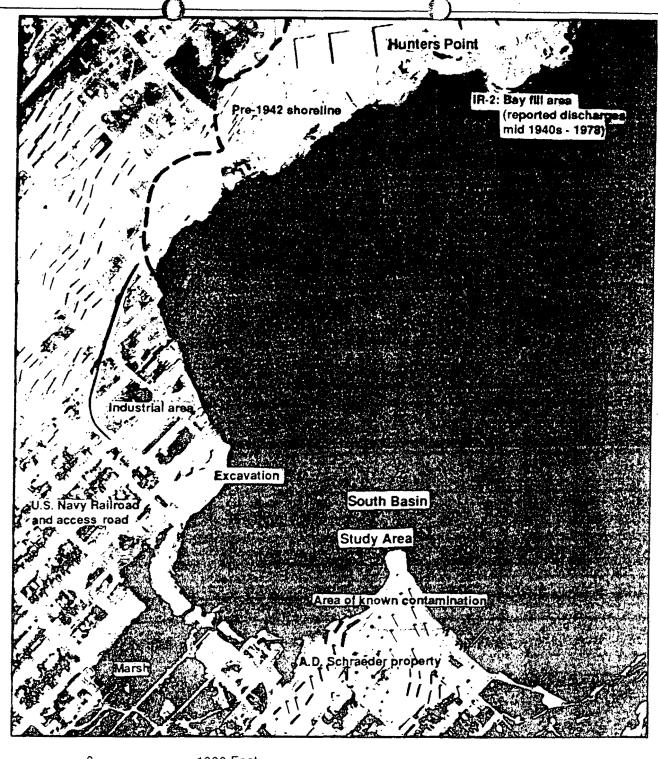
Job Number Date Plate
9011 11/89 6

0 1000 Feet (Approximate)

Photo base: National Archives,

Examination of this photograph illustrates that a substantial portion of the subject property had been filled, including the area of known contamination and most of the area inclusive of Hawes Street and Yosemite and Armstrong Avenues. Despite the poor definition of the photograph, features observable within the subject property include 1) an apparent access route for traffic oriented parallel to the South Basin Canal, 2) a large area of dark staining which includes a portion of the area of known contamination, and 3) an apparent runoff channel situated between the boundary of the A.D. Schraeder yard and the subject property.

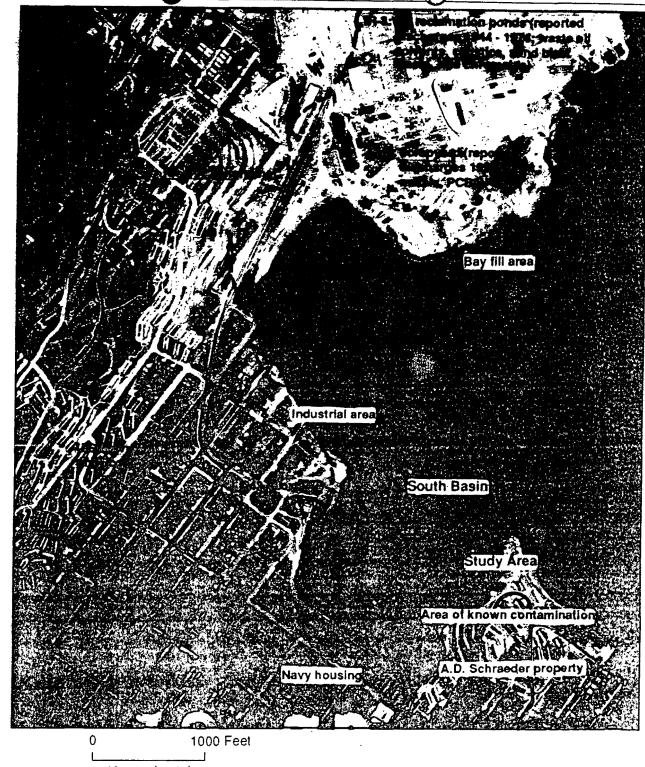
9011
 11/89
 7

Photo base: National Archives, Photograph 2-87 GS-CP

observable. Two trucks are observed in the process of leaving the site. The large area of dark staining, visible on the above referenced photograph and roughly coincident with the area of known contamination, appears to be full of debris and material, including items such as lifeboats and rafts, and wood or metal scrap. enlargement of the subject property area, not reproduced herein, was also examined. Examination of the enlargement appears to indicate that a depression may have been present in the area of known contamination. Material or liquid within the depression is highly reflective, or shows a distinct mottling and/or interplay of alternately highly light absorbing and light reflecting liquid or material. A partially filled, dark stained runoff channel is also visible. Drainage of the channel to the bay appears to be obstructed by a mound of fill.

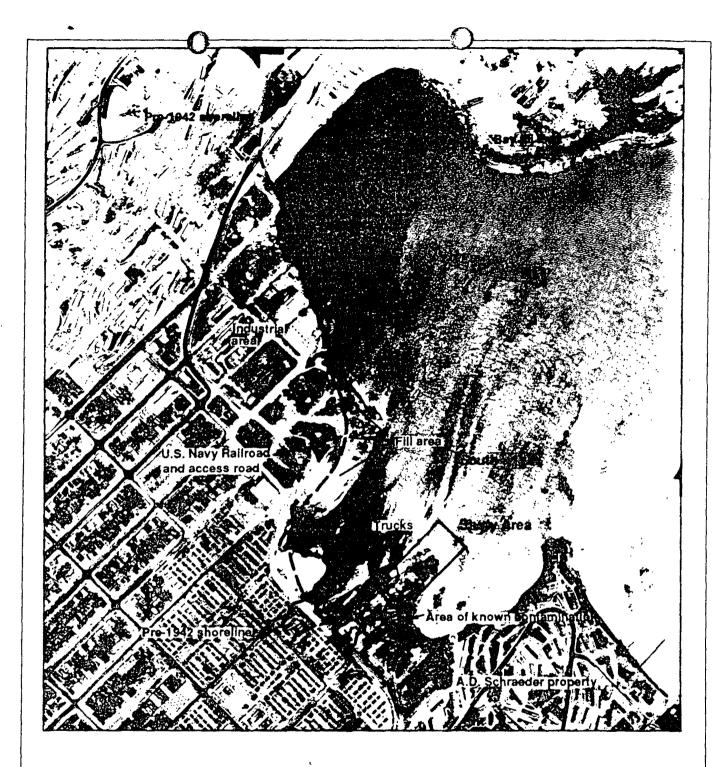
Job Number	Date	Plate
9011	11/89	8

Photo base: Pacific Aerial Surveys
Photograph AV-17-12-12
7/28/48

The subject property likewise shows signs of filling and grading, although activities appear to have been preliminary in scope. The area of known contamination, formerly an apparent depression, appears to have been filled to approximate grade. Fill and dumping activities appear to be concentrated in an area in closer proximity to the present position of Griffith. A burn area and an apparent pit are observable outside the approximate limit of the subject property. The location of the pit is roughly coincident with a portion of the area presently defined by the intersection of Armstrong Avenue (extension) with the above referenced Tide Land Commission railroad right of way, presently zoned for public use, and apparently owned by the city.

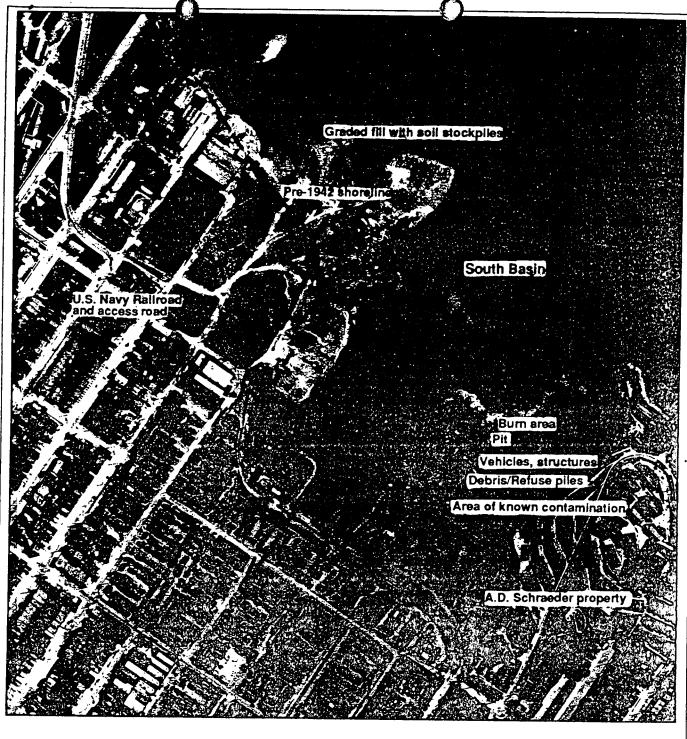
9011
 11/89
 9

Photo base: National Archives, Photograph 4VV5RTM 212B 5SRG 1/30/51

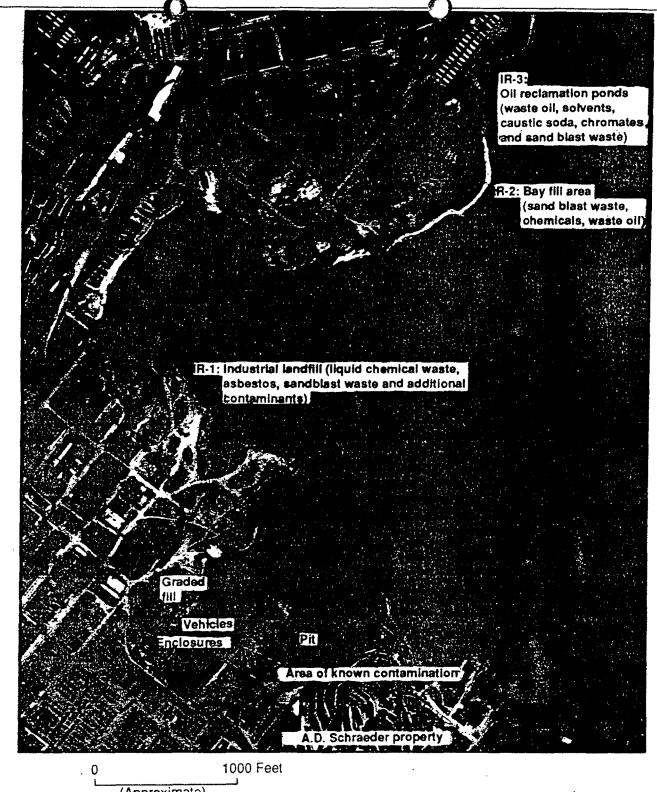
Job Number Plate Date 9011 11/89 10

Photo base: National Archives.

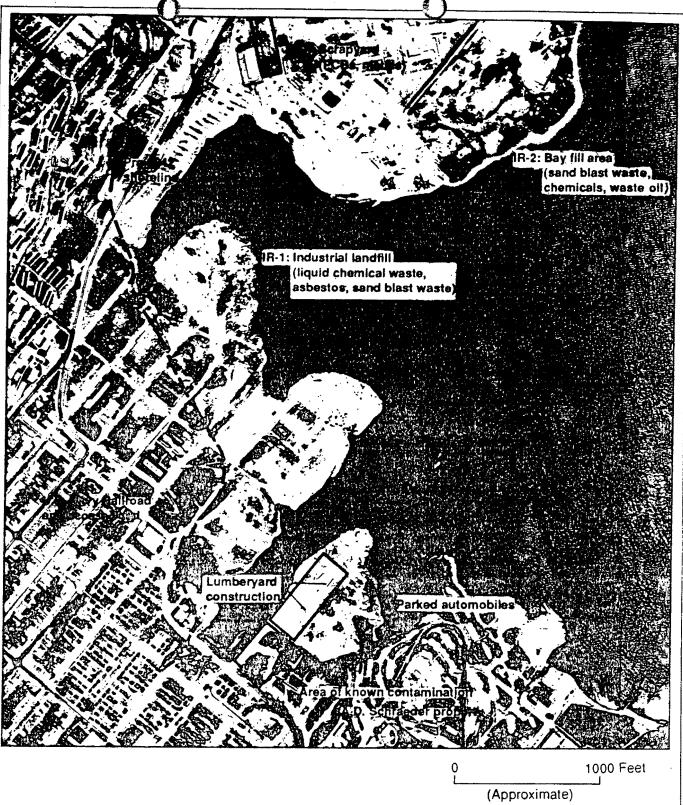
Job Number Date Plate 9011 11/89 11

Photo base: Pacific Aerial Surveys Photograph AV-170 08 14

5/5/55

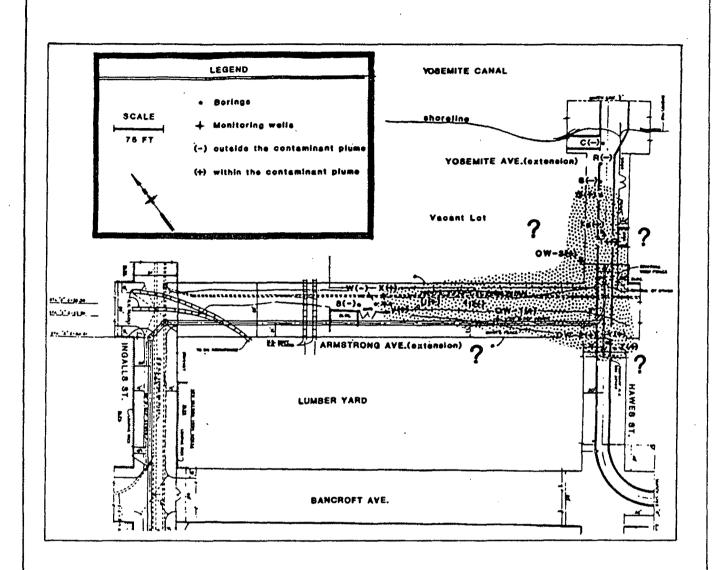
Reference: "Estimated extent of subsurface contaminant plume,
Armstrong and Hawes"
ERM-West, 1987

Pertaining to the known extent of subsurface contamination, as ascertained from the exploratory work performed by ERM-West (discussed below), it appears that the configuration of a portion of the contamination plume closely approximates the former border of the A.D. Schraeder railroad yard. Review of oblique and overhead aerial photography suggests the area adjacent to the A.D. Schraeder fence line may have been characterized by a large depression of irregular morphology and topography, which may have extended up to 100 feet into the subject property. Dark staining observable on several photographs suggests that additional contamination may be present beneath the subject property in the vicinity of the area of known. contamination. It is further noted that an apparent runoff channel appears to have been situated between the boundary of the A.D. Schraeder yard and the subject property, and may have contributed to discharges of liquid to the bay.

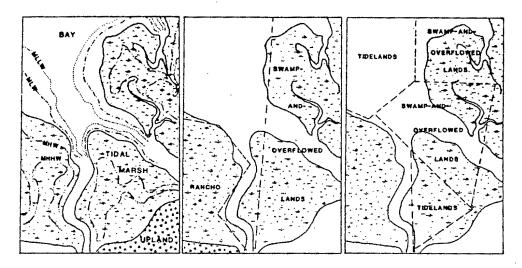
Fig. 1. Projection of tidal datums (left) and property lines (center and right) onto a hypothetical tidal marsh. Center diagram shows lines surveyed by the U. S. Government after the anaexation of California in 1848. The ranch was granted to a private party by either Spain or Mexico before annexation, confirmed by the American Board of Land Commissioners after annexation, and subsequently surveyed by the Federal government. The government was also required to identify the "swamp-and-overflowed lands" that it granted to California on 28 September 1950, and often did so by survey. Surveyors were not always careful to locate the true "ordinary high water mark," or as it has been defined by some courts, the mean high water line. Nonetheless the true boundary remains the ordinary high water mark, no matter how erroneous the survey, which was run chiefly to compute acreages. California laws enacted in 1850 authorized the sale to private purchasers of tidelands and swamp-and-overflowed lands. These sales were made according to surveys that frequently did not correspond to the Federal surveys, much less the actual topography. The right-hand figure depicts a typical pattern of surveys done for these State sales. This lack of congruence between the true physical conditions and the designations of title documents creates many title disputes today.

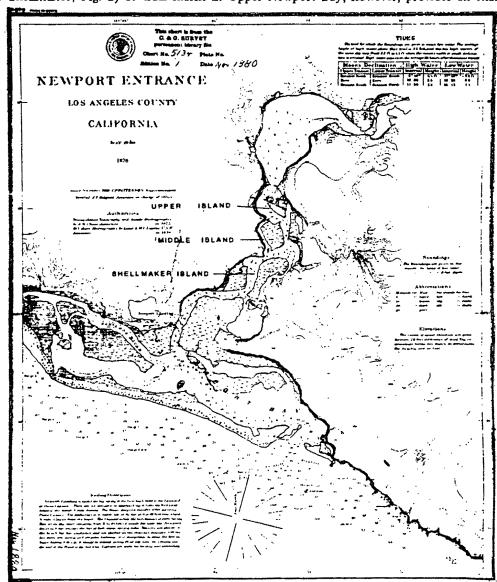
Fig. 2. Nautical chart of Newport Bay, California, published in 1878 by the U.S. Coast and idetic Survey.
